Rapport sur le suivi morphosédi- mentaire du sillon de Talbert pour l'année 2018

**COMMUNE DE PLEUBIAN (CÔTES D'ARMOR) ET
CONSERVATOIRE DE L'ESPACE LITTORAL ET DES RIVAGES LACUSTRES**

***Suivi morphologique du Sillon de Talbert pour l'année 2018
(Commune de Pleubian – Période d'octobre 2017 à septembre 2018)***

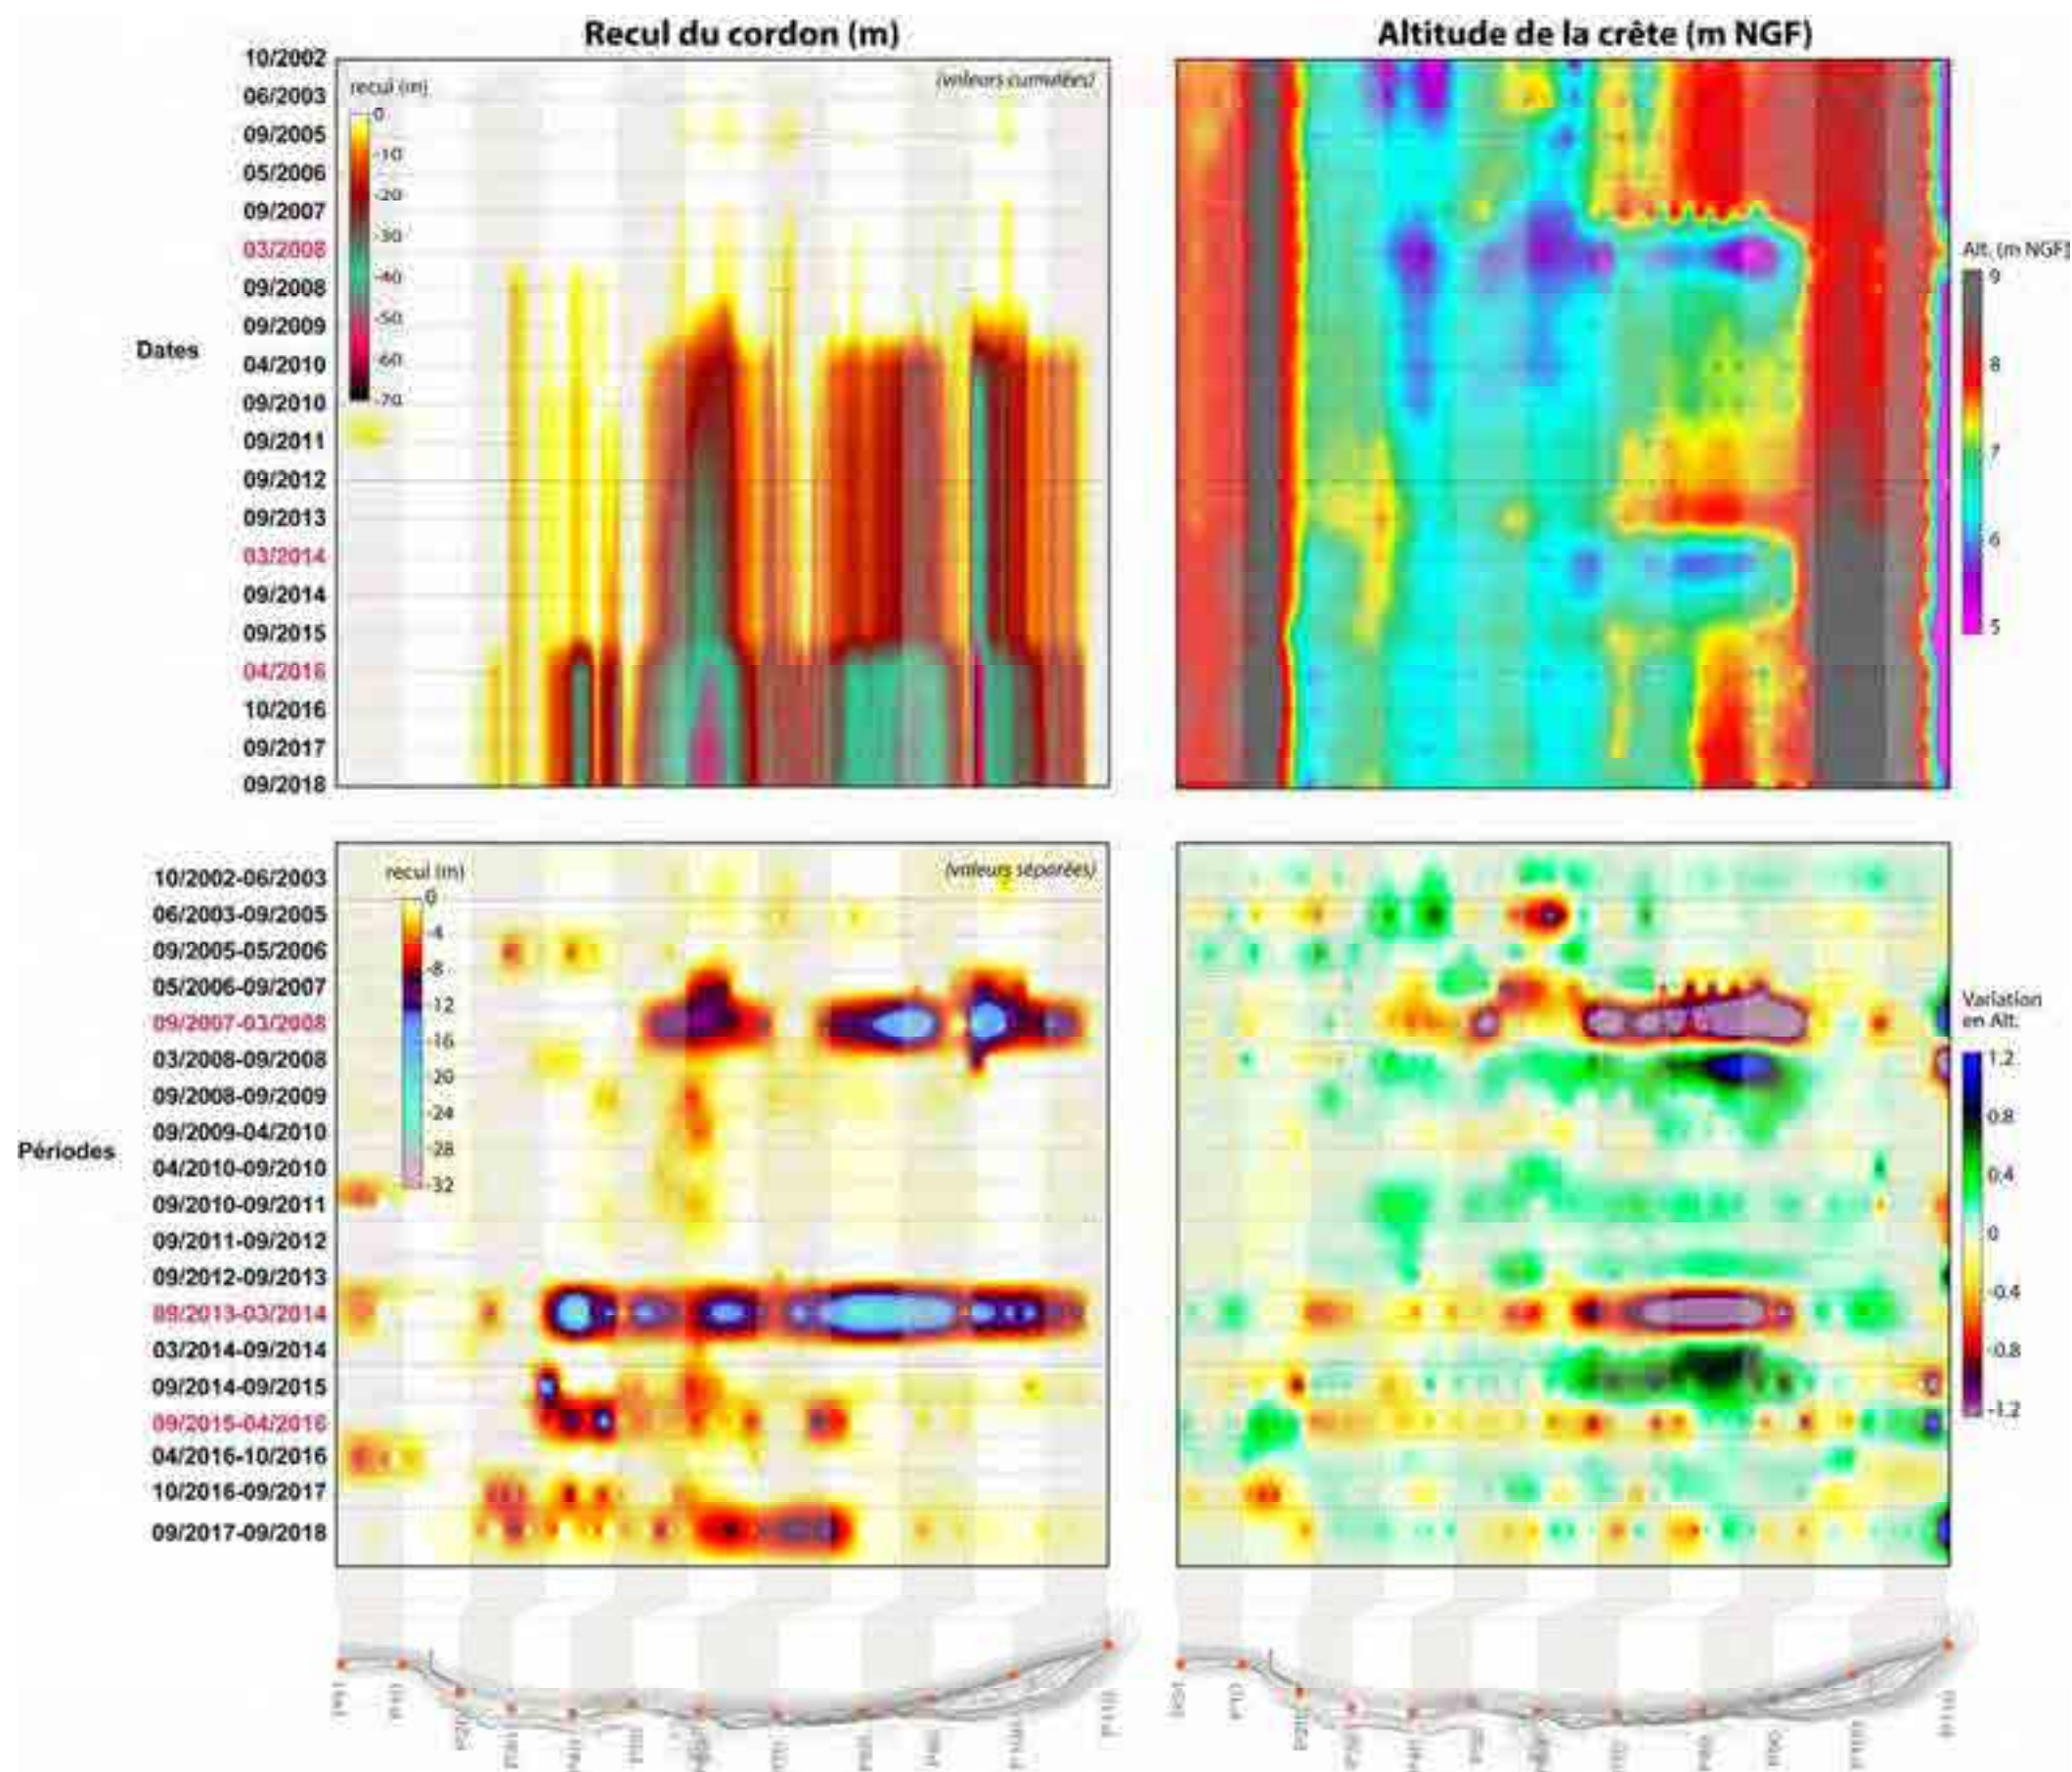
Figure 5 : valeurs du recul et de la hauteur du sillon de Talbert depuis le début des suivis en 2002.

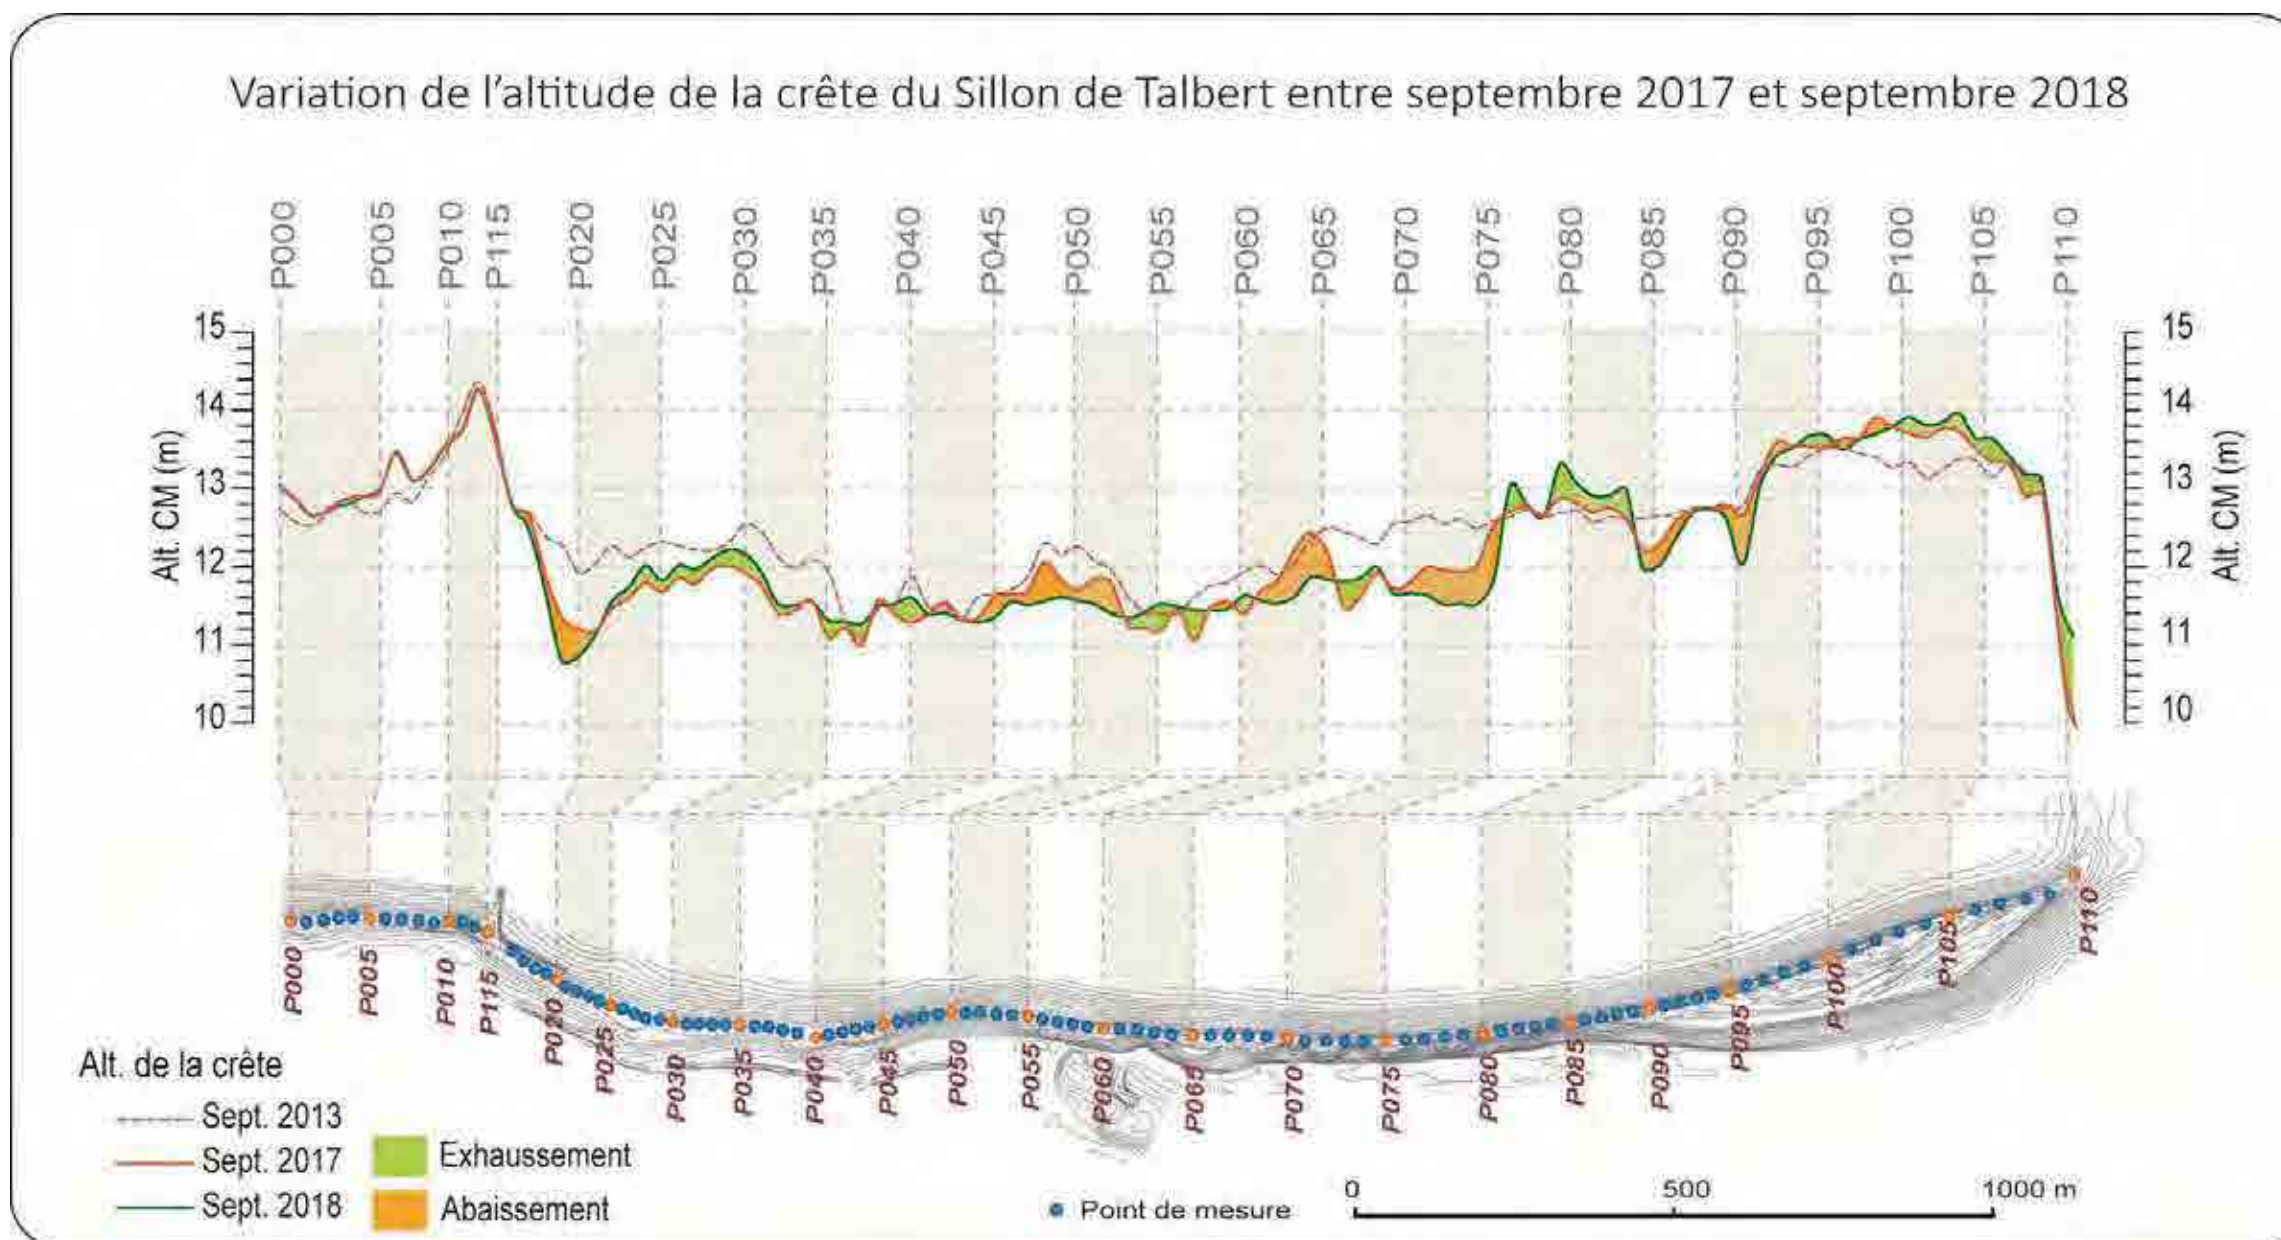
Figure 6 : Variations de l'altitude de la crête du Sillon de Talbert de septembre 2017 à septembre 2018.

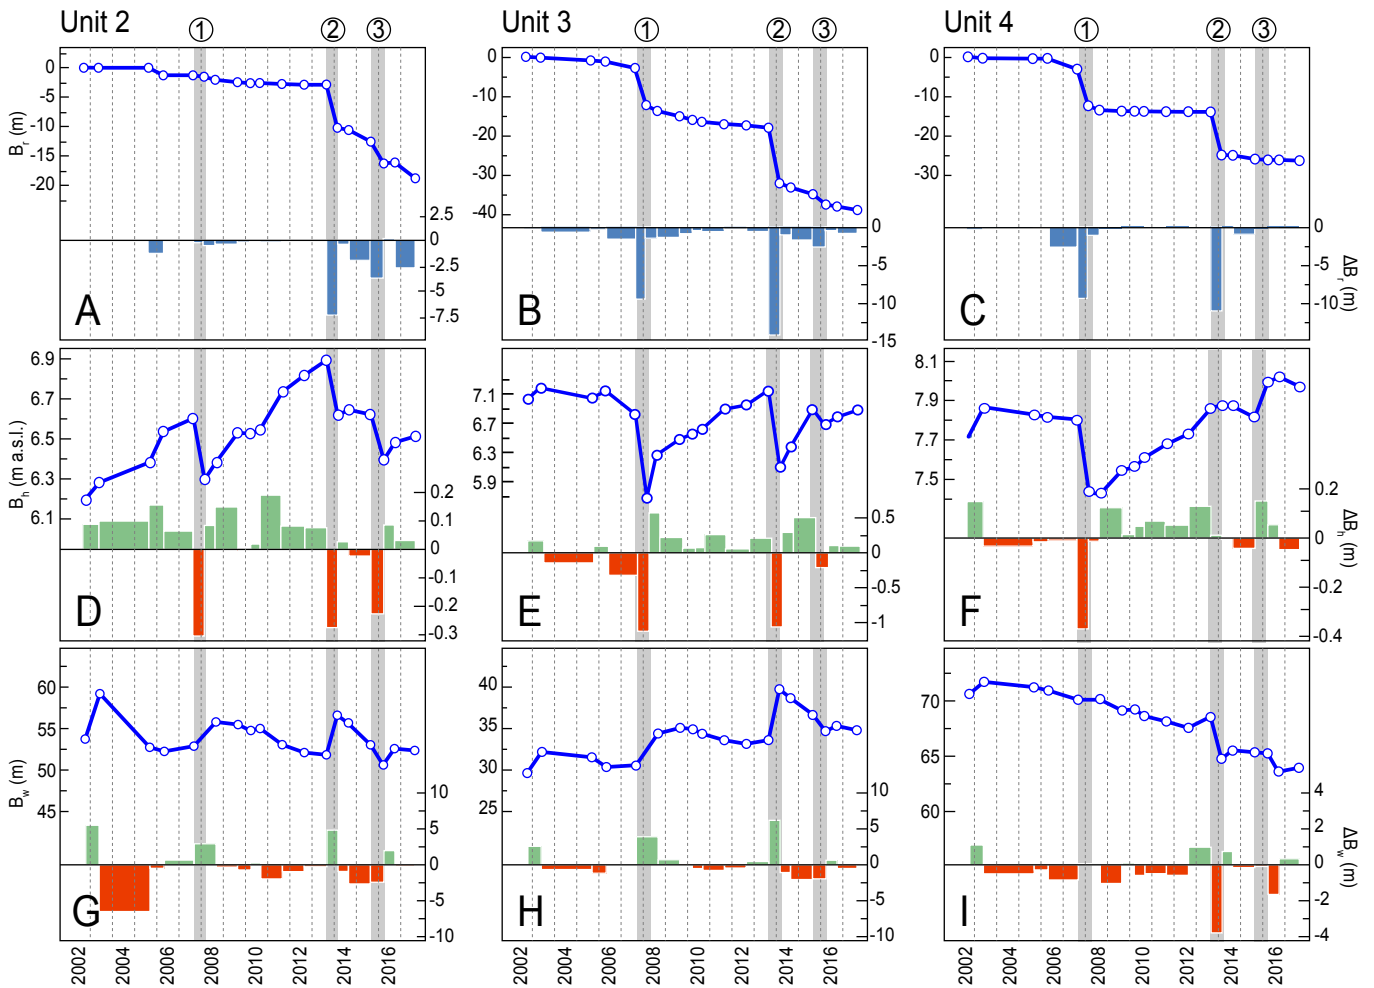
Fig. 7 - Annual morphological changes along the three morphosedimentary units of the Sillon de Talbert from 2002 to 2017.

Unit 2: proximal gravel section; Unit 3: median section; Unit 4: distal section (see Figure 3). A-C: Barrier retreat in cumulative frequency B_r (curve), and frequency ΔB_r (bars), for the proximal gravel section - Unit 2 (A), for the median section - Unit 3 (B), and for the distal section - Unit 4 (C). D-F: Barrier height changes in cumulative frequency B_h (curve), and frequency ΔB_h (bars) for the proximal gravel section - Unit 2 (D), for the median section - Unit 3 (E), and for the distal section - Unit 4 (F). G-I: Barrier width changes in cumulative frequency B_w (curve), and frequency ΔB_w (bars) for the proximal gravel section - Unit 2 (G), for the median section - Unit 3 (H), and for the distal section - Unit 4 (I). Grey bars correspond to main morphogenetic events (1. in 2008; 2. in 2014; 3. in 2016).

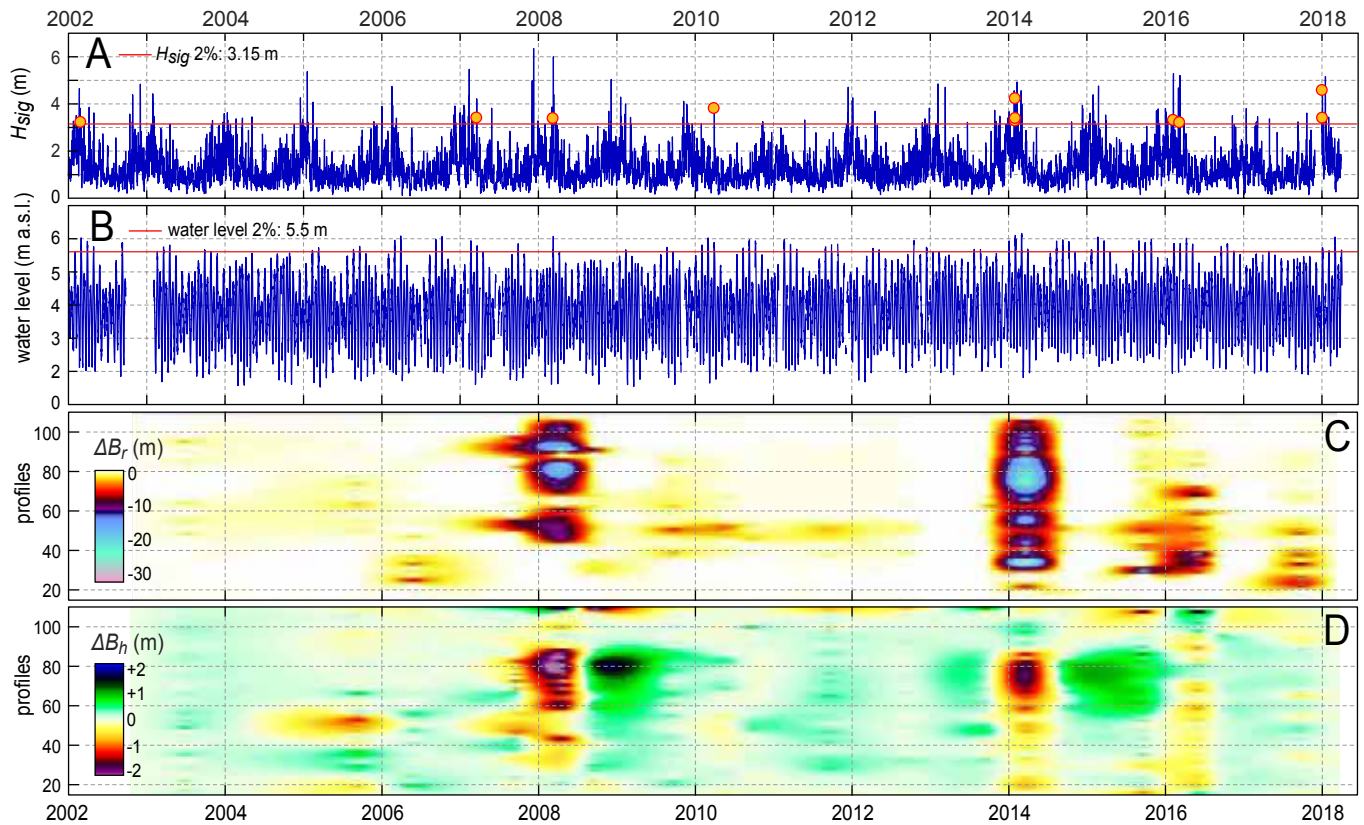
Fig. 8 – Hydrodynamic conditions and morphological changes of Sillon de Talbert from 2002 to 2018.

A. Time series of significant wave heights (H_{sig}) from WW3 modeling data (see the location of the calculation point on Figure 2) where a morphogenetic event (orange dot) is defined as a significant wave event during which the maximum H_{sig} exceeds the 2% exceedance wave height of 3.15 m (threshold red line), combined with water levels exceeding the 2% exceedance water level. B. Time series of water levels (tide and surge calculated from data collected at Les Héaux lighthouse by the SHOM 2016) (see location on Figure 2) for both daily high tides. The threshold red line corresponds to the 2% exceedance water level of 5.5 m a.s.l. C. Barrier retreat along the 110 cross-shore profiles. D. Barrier height variations along the cross-shore profiles.

retreat ΔB_r and barrier height ΔB_h) was then analysed (fig. 8C-D). The results show a significant association between these extreme events and the morphological response of the barrier. For example, this is the case for the morphogenetic events related to storm Johanna on March 10, 2008, where a maximum retreat of up to -22 m was recorded on the median and distal sections, and during the winter of 2013-2014 where the cluster of storms generated a maximum retreat reaching -30 m, while the major part of the median section retreated from -20 to -22 m (fig. 8C). The extreme event related to storm Ruzica/Imogen on February 8, 2016 also produced a maximum landward spit migration of up to -20 m on the proximal gravel section, and between -5 to -10 m on the median section. The results obtained for the crest lowering/elevation ΔB_h showed the same behavior with significant crest erosion of up to -2.5 to -2 m in association with these three morphogenetic events (fig. 8D).

Medium to short-term morphodynamic monitoring is very efficient in identifying and quantifying the variations in meteorological conditions. Between 2002 and 2007, a long phase was identified as a "calm" period in terms of morphogenetic conditions. The wave conditions showed no significant storm activity, with $H_{sig} < 5 \text{ m}$, except for the event of January 18, 2005 (5.37 m), which occurred during a neap tide period. During this 5-year period no significant morphological changes were recorded (fig. 8).

(tab. 2). However, despite the severe meteo-oceanic conditions that characterized this event, the morphological changes experienced by the spit were limited to a small part of the barrier (fig. 8).

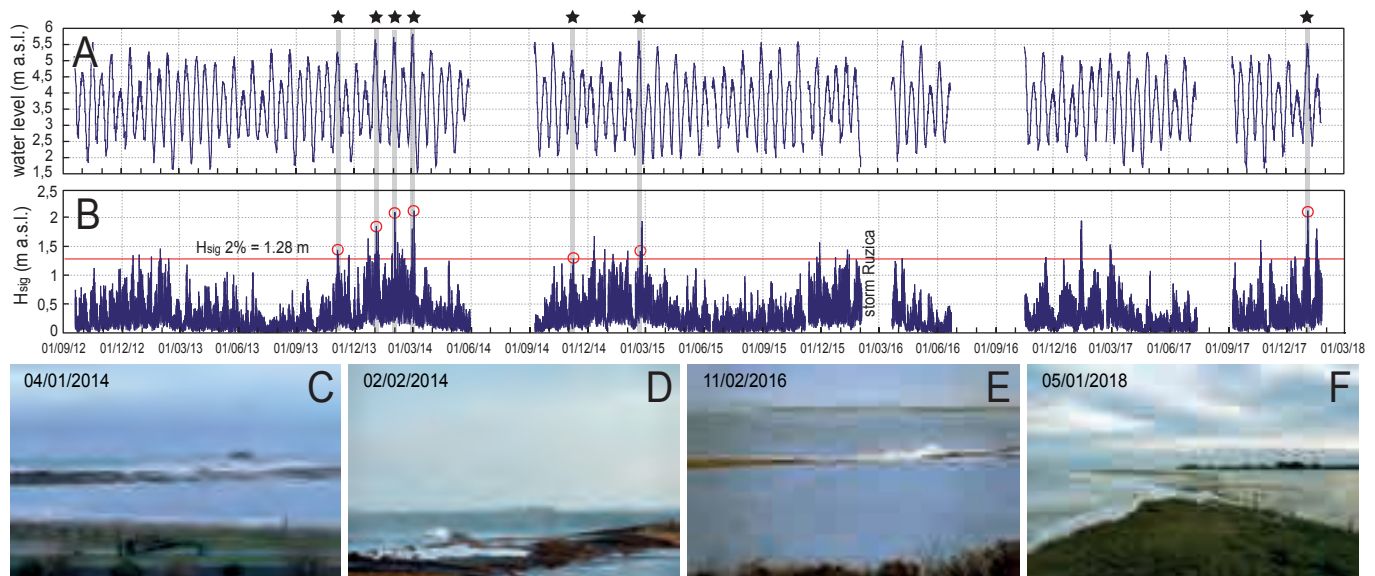
Fig. 10 – Hydrodynamic conditions recorded by the OSSI pressure sensor between September 2012 and January 2018.

A. Water level corresponding to both daily high tide levels. B. Time series of significant wave height H_{sig} with maximum H_{sig} exceeds the 2% exceedance wave height of 1.28 m (red line). Grey bars + red circles and black stars identify the most significant morphogenetic events, where H_{sig} exceeded the threshold of 2% exceedance of 1.28 m combines with spring tide conditions. C and D: sluicing to catastrophic overwash of the Chouck beach (proximal dune section) during the both severe storm events of January 3-4, 2014, and February 2, 2014, respectively. E and F: sluicing to catastrophic overwash of the proximal gravel section (down drift of Chouck groin) during both high energetic periods of February 11, 2016 (less than 3 days after the Ruzica/Imogen storm of February 8, 2016), and January 5, 2018 (less than two days after the Eleanor storm of January 3-4, 2018). Photo credit: 04/01/2014 (Jacky Laveaud); 02/02/2014 (Gabriel Le Boubennec); 11/02/2014 and 05/01/2018 (Julien Houron). See location of the photos in Figure 6.

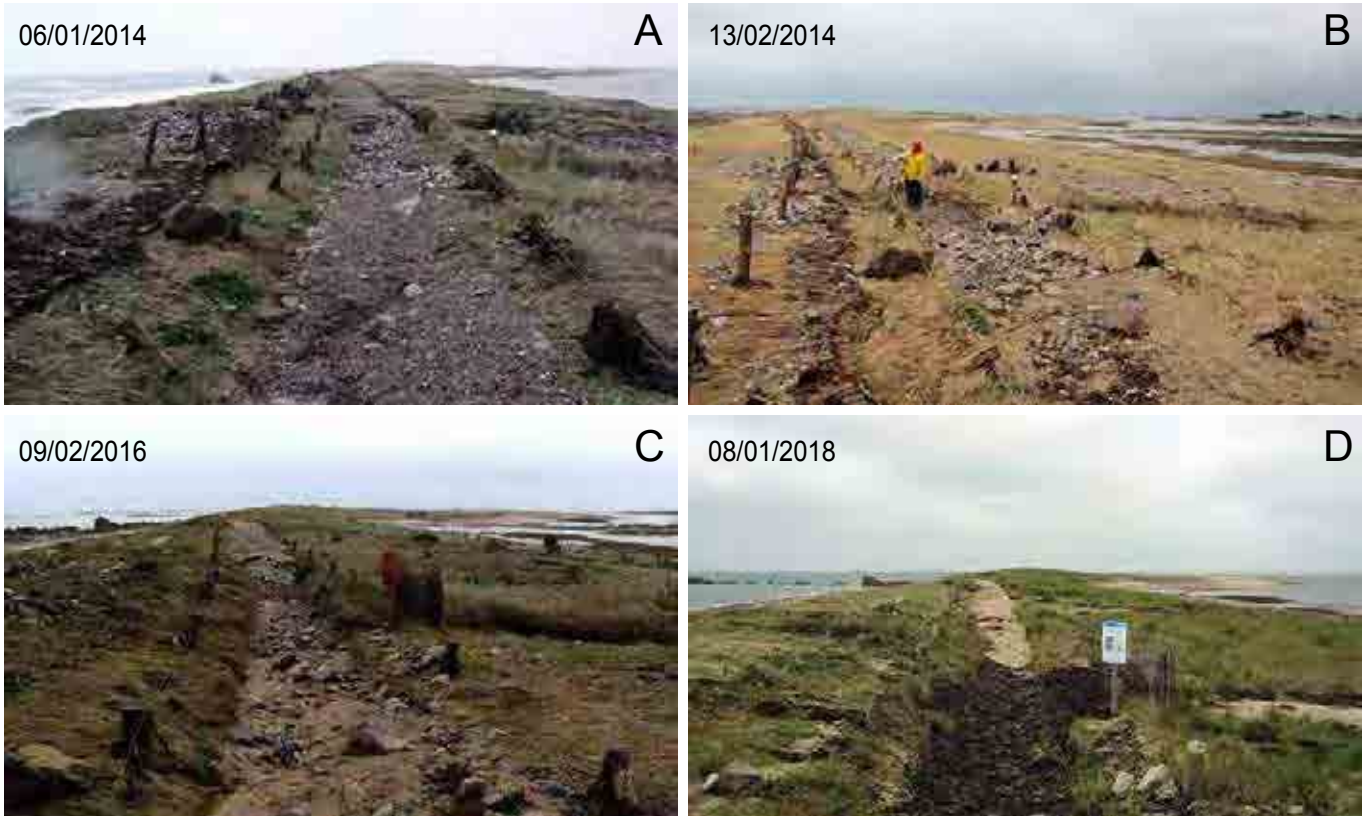
Fig. 11 – Photos illustrant overwashing processes under a sluicing to inundation regime on the proximal dune section (Chouck beach).

Les dépôts de sédiments grossiers et la végétation couchée donnent des informations sur la puissance et la direction des flux. Sources photographiques : A et B (Serge Suanez) ; C et D (Julien Houron). Voir la localisation des photos sur la Figure 6.

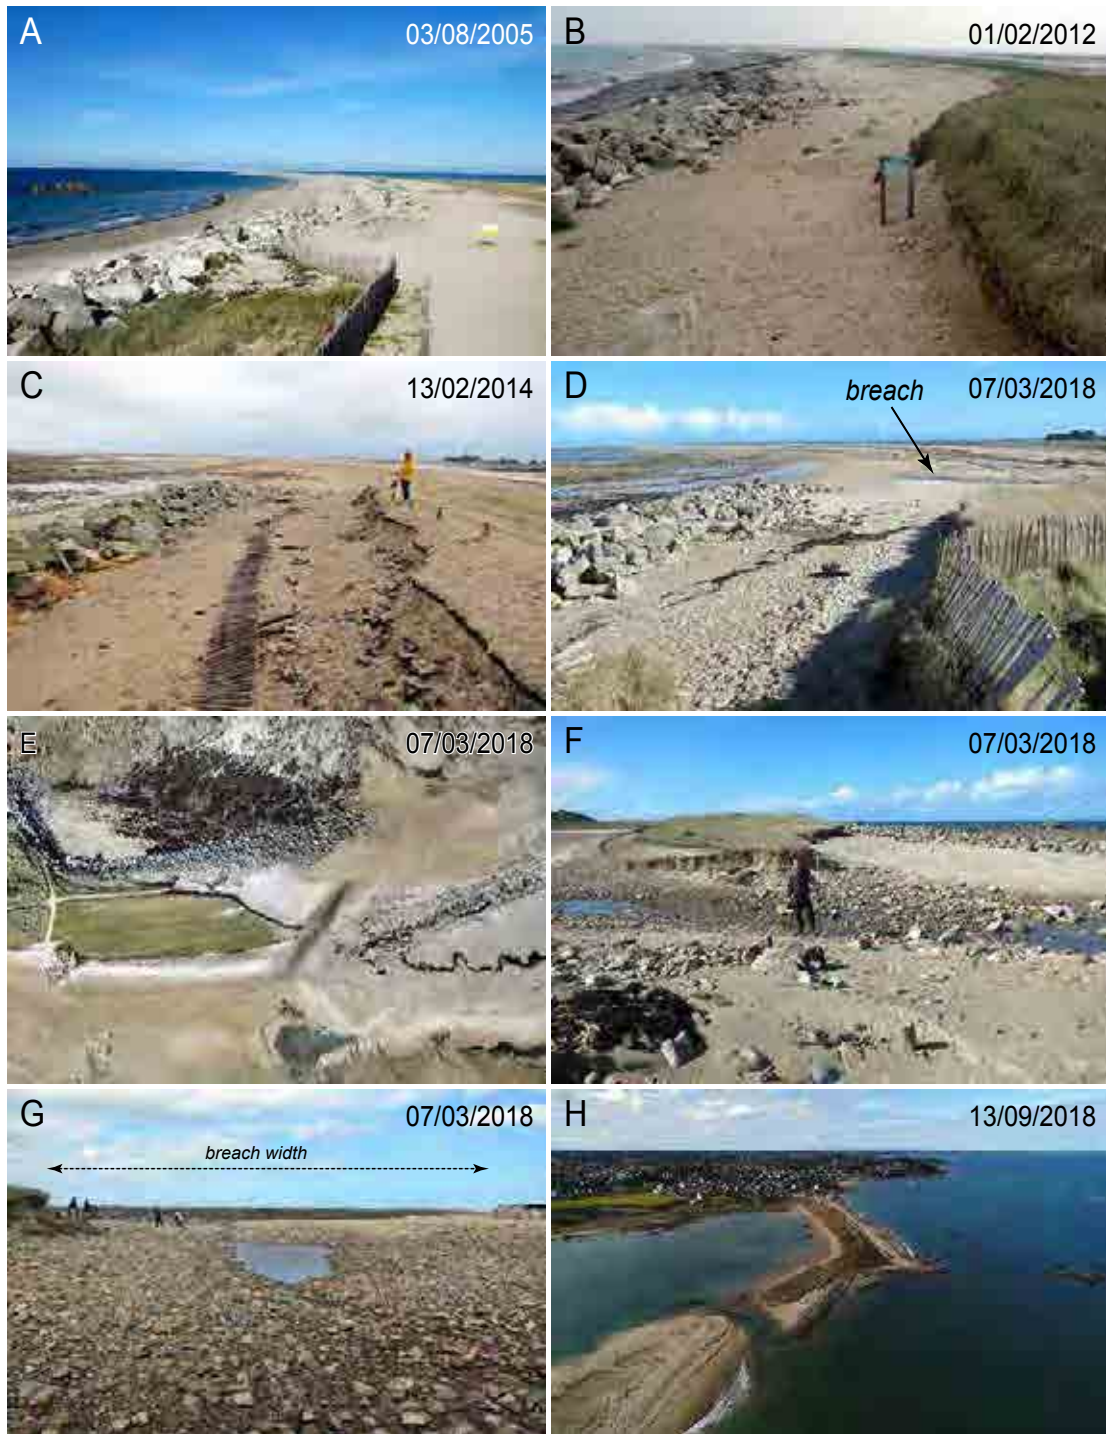
Fig. 13 - Morphological changes of the proximal section situated down-drift of the Chouck groin between 2005 and 2018.

A. Photo prise le 03/08/2005 montrant la section dunaire –à cette date non végétalisée– connectée à l'enrochement (crédit photo : Julien Houron). B. Photo prise le 01/02/2012 montrant la section dunaire complètement végétalisée –après que la restauration des dunes ait été entreprise par le *Conservatoire du littoral*–, déconnectée de l'enrochement par l'érosion du trait de côte (crédit photo : Julien Houron). C. Photo prise le 13/02/2014 après la grosse tempête du début du mois de février 2014 qui a généré une importante érosion du trait de côte et une destruction des ganivelles (crédit photo : Serge Suanez). D. Photo prise le 07/03/2018, quelques jours après l'ouverture de la brèche (crédit photo : Serge Suanez). E. Ortho-photographie aérienne de la brèche produite par un levé au cerf-volant le 7 mars 2018 (crédit photo : Pierre Stéphan). F. Photo prise le 7 mars 2018 montrant la profondeur de la brèche (crédit photo : Serge Suanez). G. Photo prise le 17 avril 2018 montrant la largeur de la brèche après une phase dynamique d'élargissement (crédit photo : Serge Suanez). H. Photo aérienne oblique de la brèche prise le 13 septembre 2018 durant une pleine mer de vive-eau (crédit photo : Pierre Stéphan). Voir la localisation des photos sur la Figure 6.

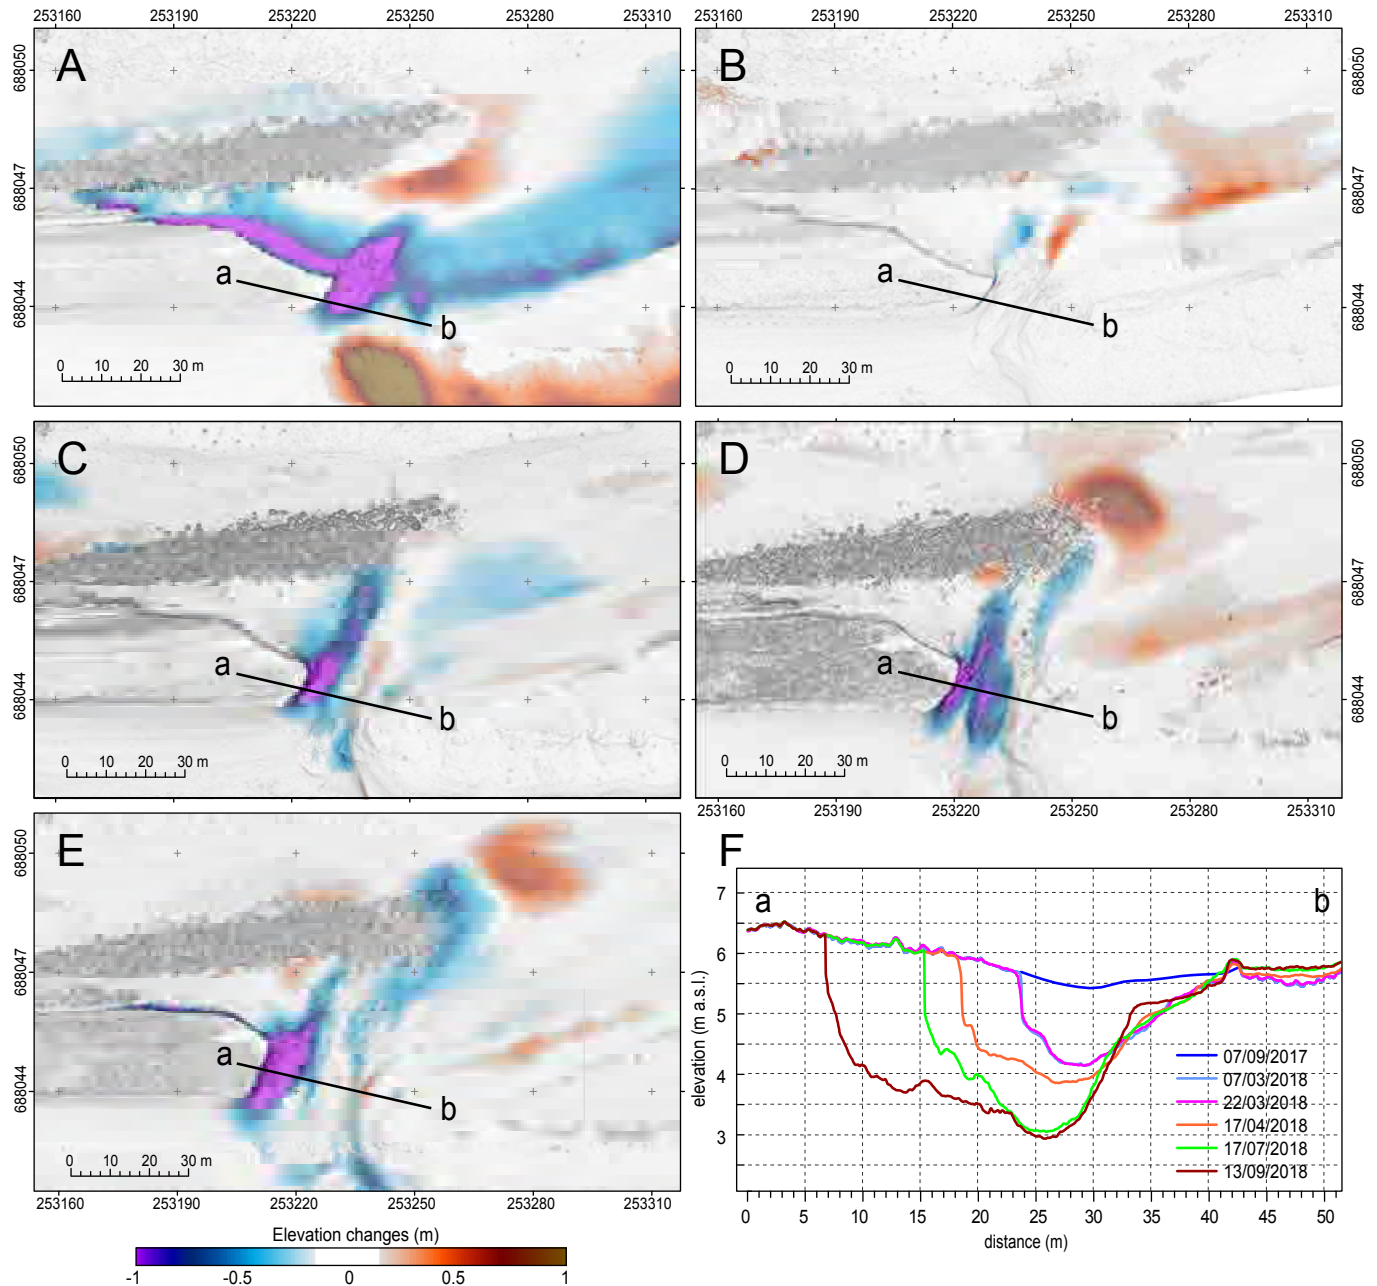
Fig. 14 – Morphological changes of the breach between September 2017 and September 2018.

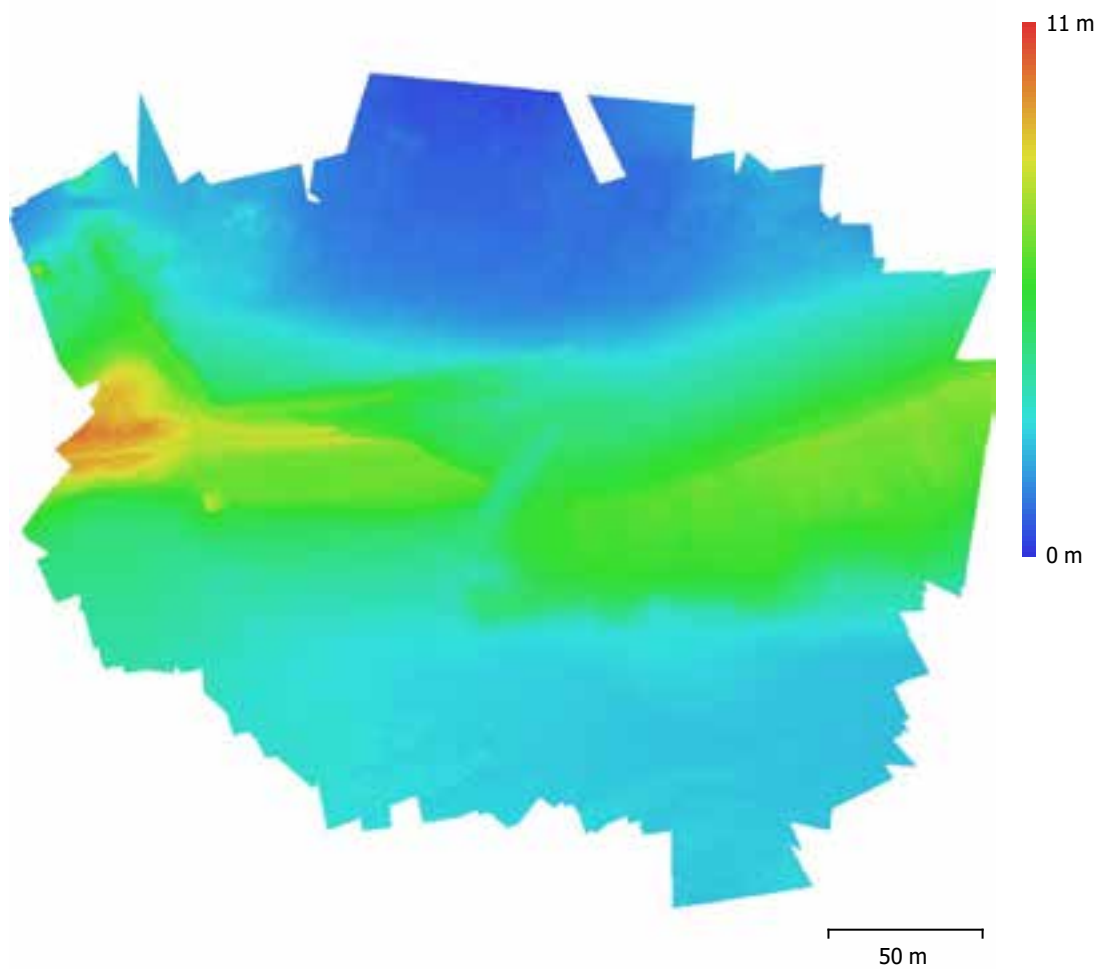
Fig. 4. Modèle numérique d'élévation reconstruit.
